Examining Thermal Pollution and Exploring Environmental Injustice in Holyrood, NL

Thermal Flashlight Project

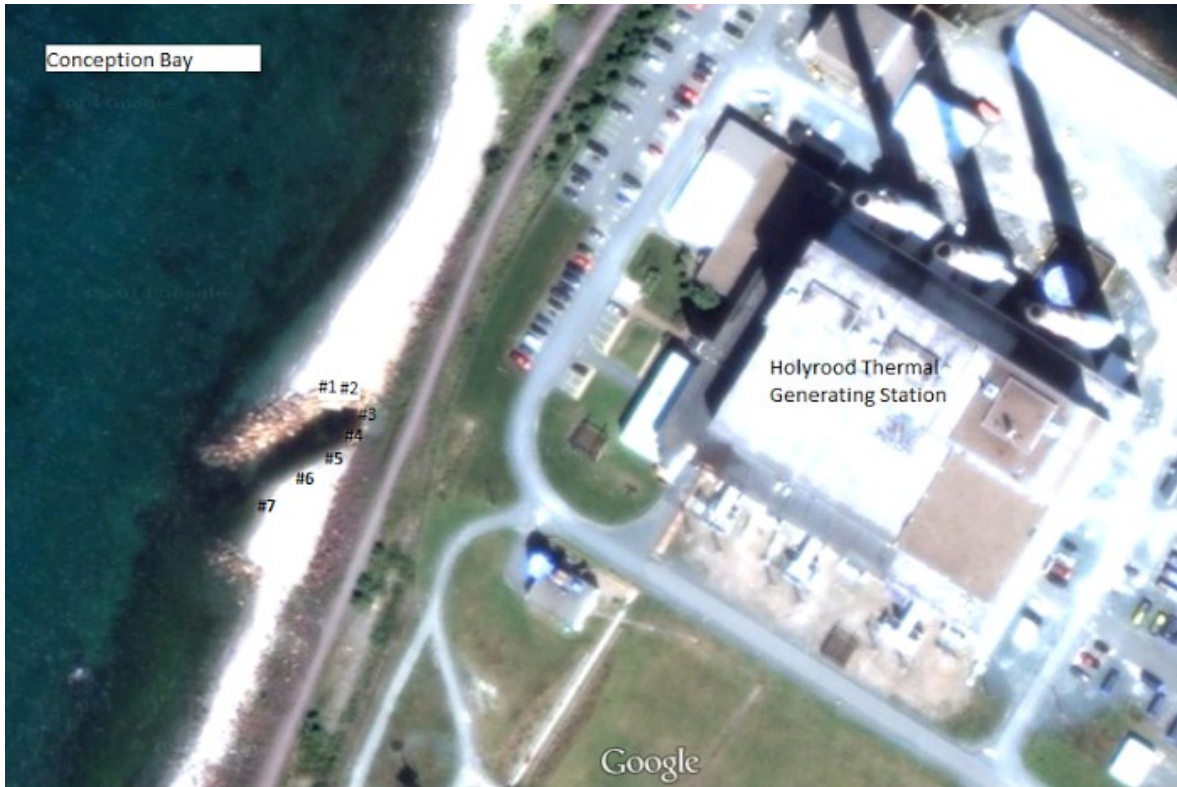
Site Map 2 – Closer aerial shot of our site

Numbers correspond to numbers on the following temperature maps. Key information is available below for locations where temperatures were collected.

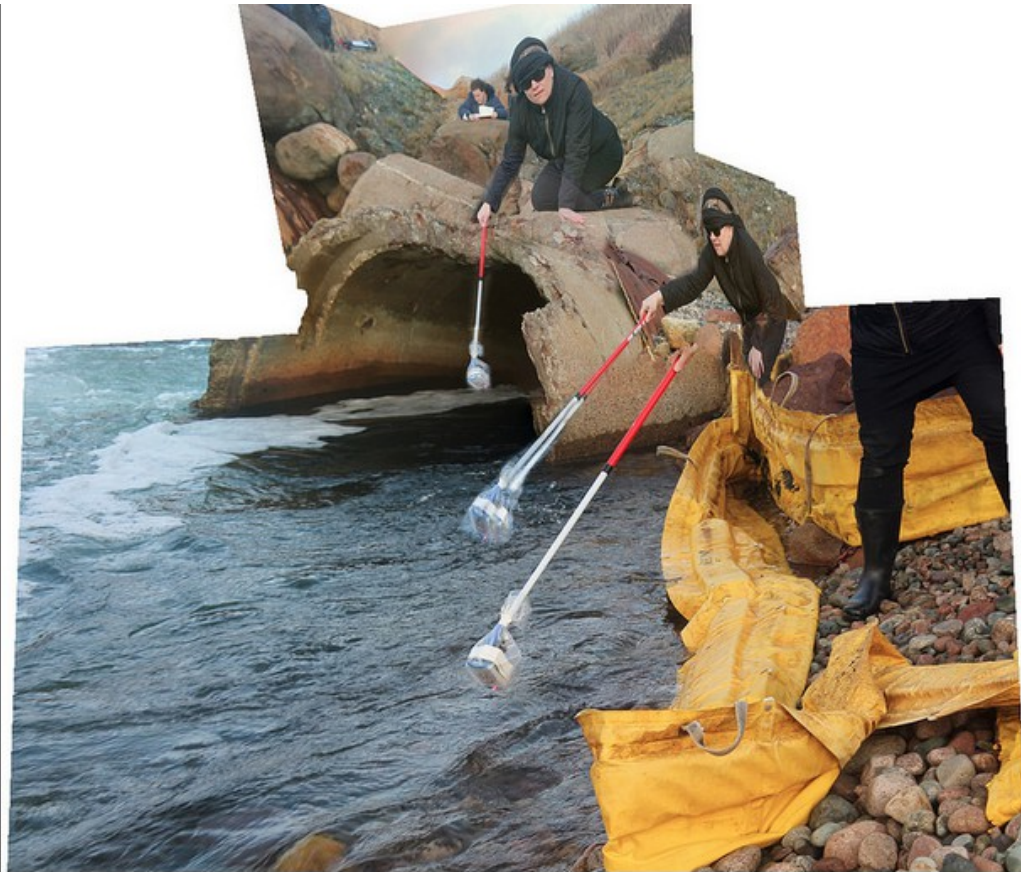
Photograph 1

This composite image is composed of three still images. We took our initial data during the daytime, and the light shows a red light, demonstrating the heat of these locations. This corresponds to locations #4, #5, and #6 on the temperature map of the previous page.

We could have further manipulated this image to draw out the light from the bulb, showing the temperature readings. This form of visualization could be beneficial if one can only reach a location during the daytime, though it is a limited form of visualization.

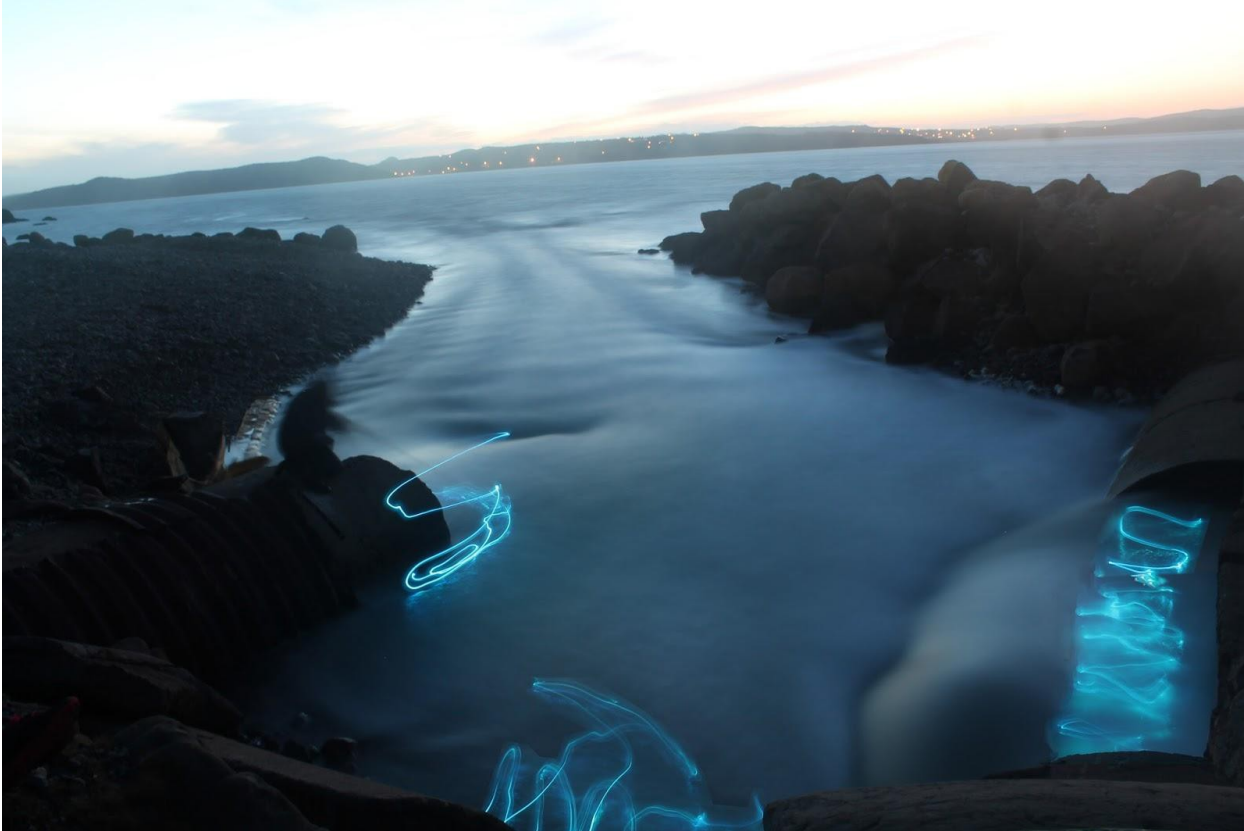
Photograph 2

This is a composite of photos we took at dusk at our site. Our technology stopped working, so these blue lines do not represent the temperature of the water. Rather, this photograph shows what data visualization would look like when testing surface water temperature using this technology.

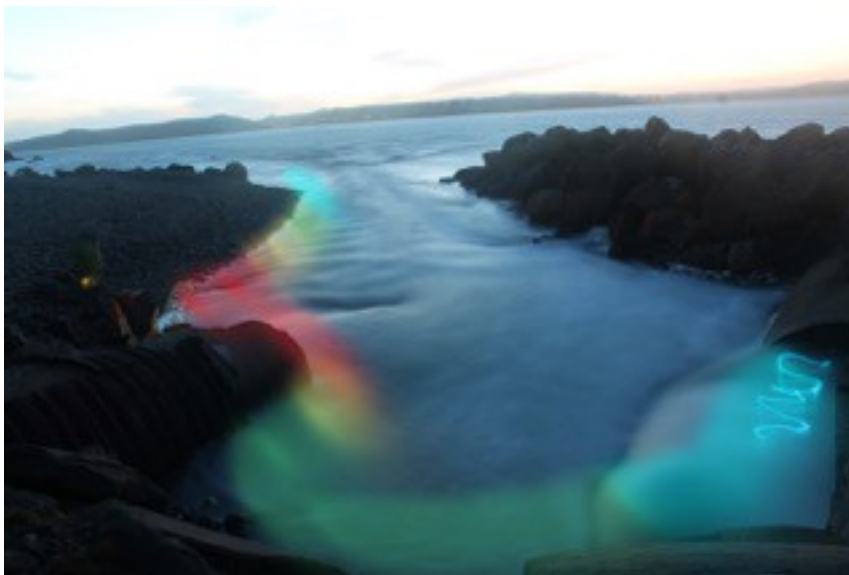
Photograph 3

This image shows what we hoped to accomplish with our thermal flashlight. This image was created with Photoshop. Based on the bathtub photos (see Field Notes 8) and our daytime data collection, we believed we could capture colour over a broader area of the water. However, as Photograph 2 shows, the flashlight realistically shows streaks of light, rather than light diffused evenly over the surface. We believe if we had put some sort of diffuser on the lightbulb itself (and had our tech not failed), we could have achieved this result.

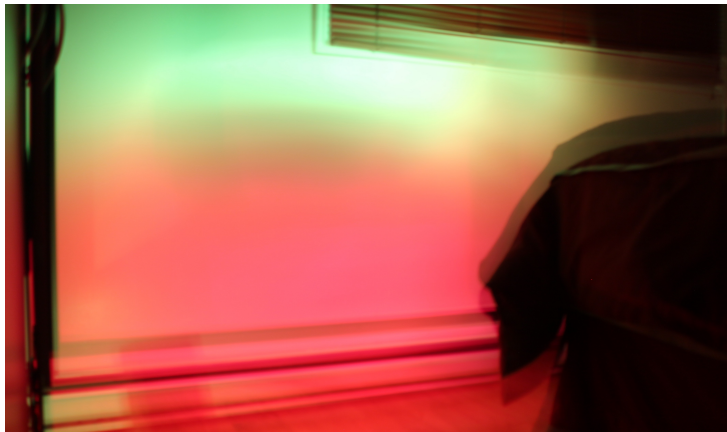
I turned the heat on and just opened the window, to try to capture the heat around the heater and some cold around the window.

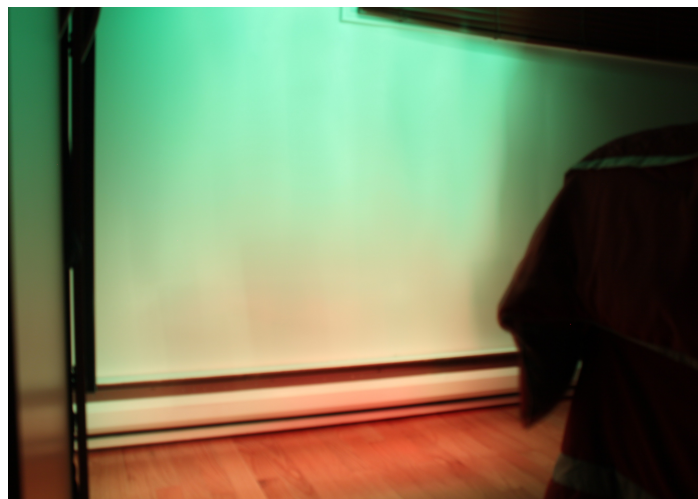
Less vibrant than the picture above because the window was open for longer, so cold air was coming in and heat was escaping.

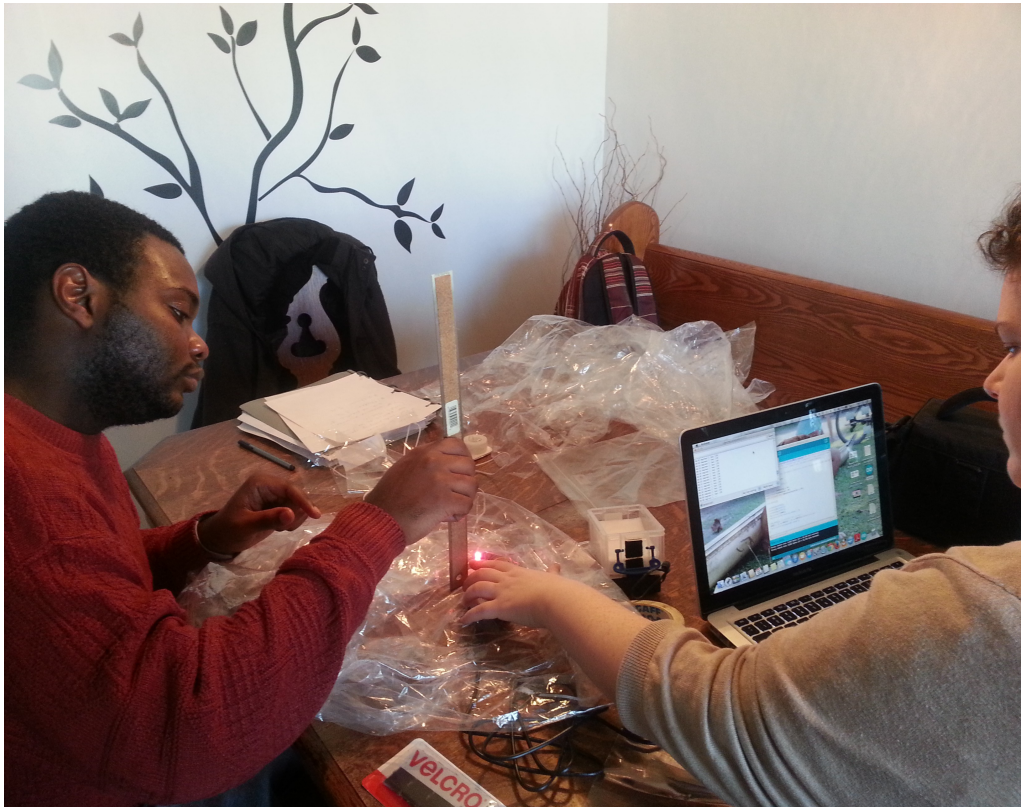
Verifying temperatures

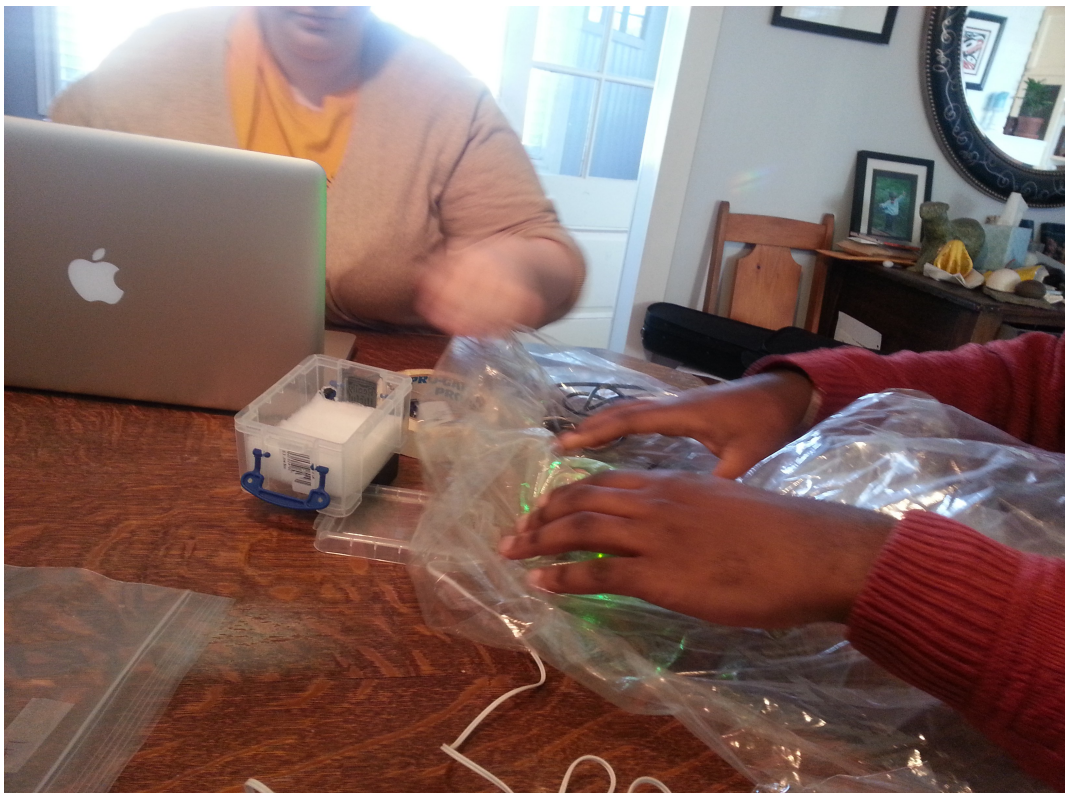
Checking temperature readings with and without plastics covering the sensor

Thinner plastic (#2) had a little bit of leakage - the tissues did get a bit wet in spots
The thicker plastic (#1) had no leakage.

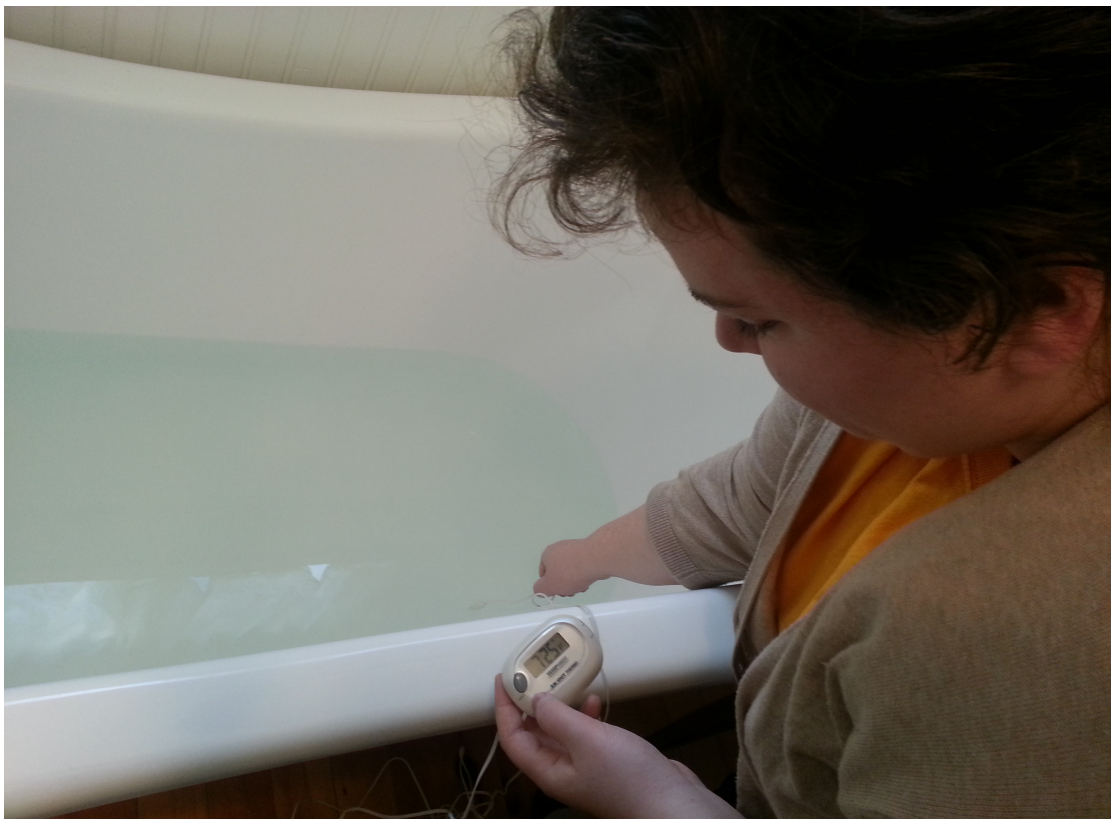
Checking water temperatures

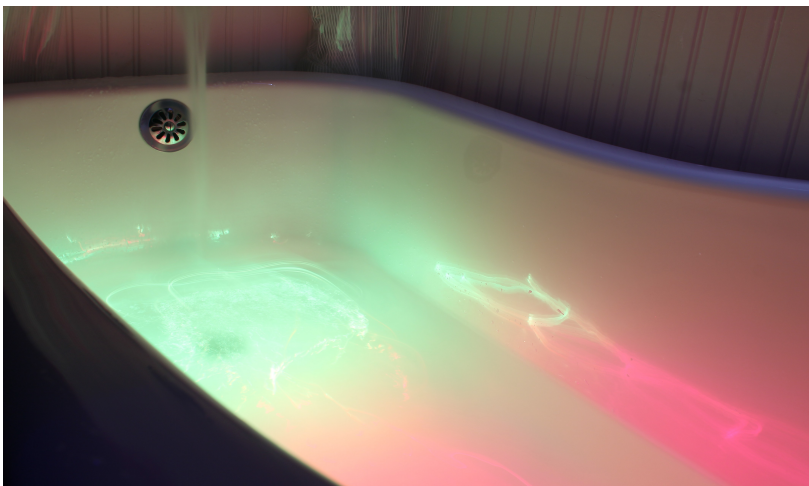
Putting cold water into hot water

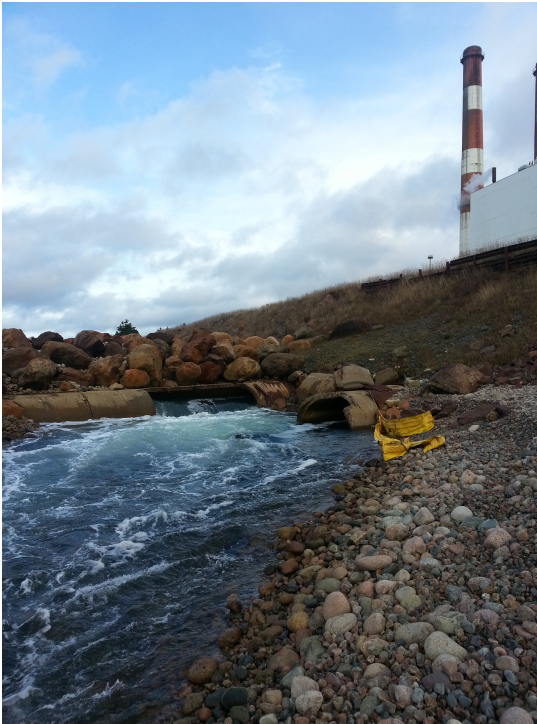
Our site with the plant in the background.

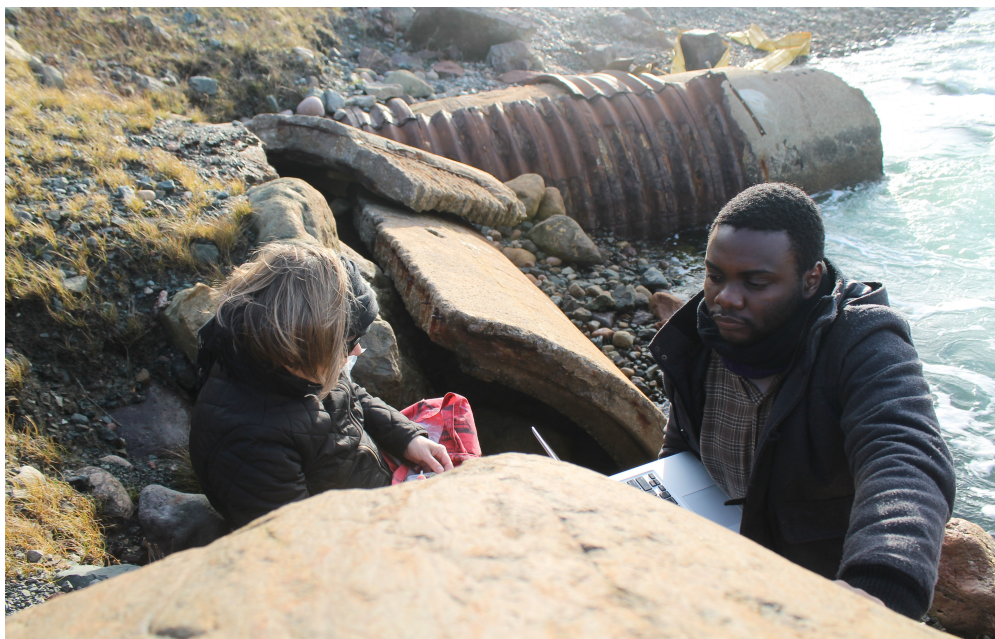
Too much technology
around too much
water.

is expected. For instance, after testing the surface of water temperature in a bathroom tub compared to that of a high pressure water source, we realized that if such a technology is not properly covered and comes into contact with water it would jeopardize any sort of accurate readings and would need replacement, which is a process in itself when working in a short period of time and trying to meet certain deadlines.

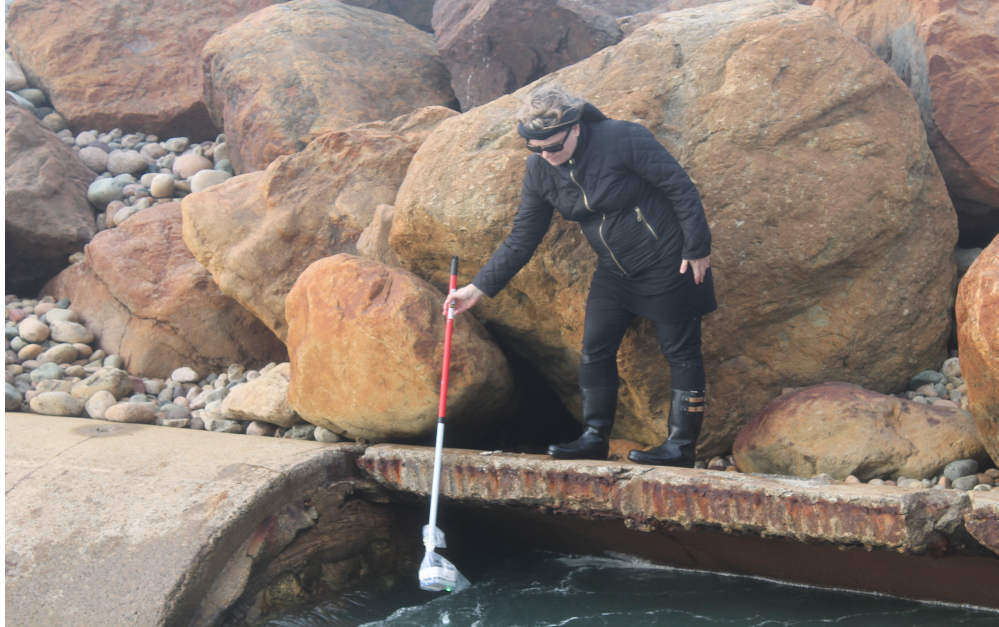
**Image One =
#1 on map****Light = Green**

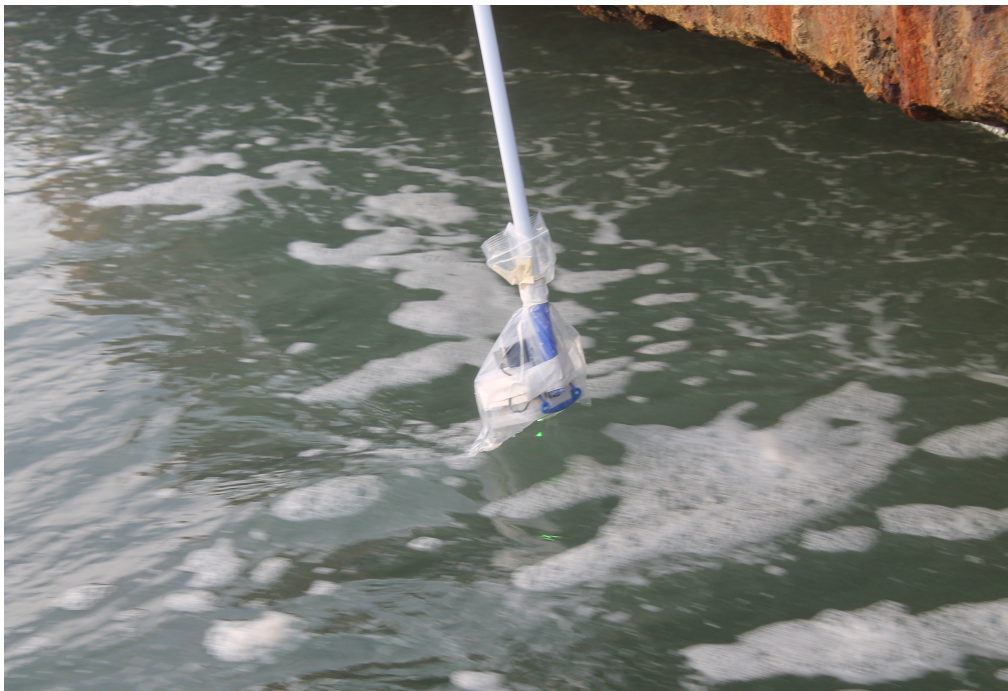
**Picture Two =
#2 on map****Light = Green
Temp =
53°F (11.67°C)**

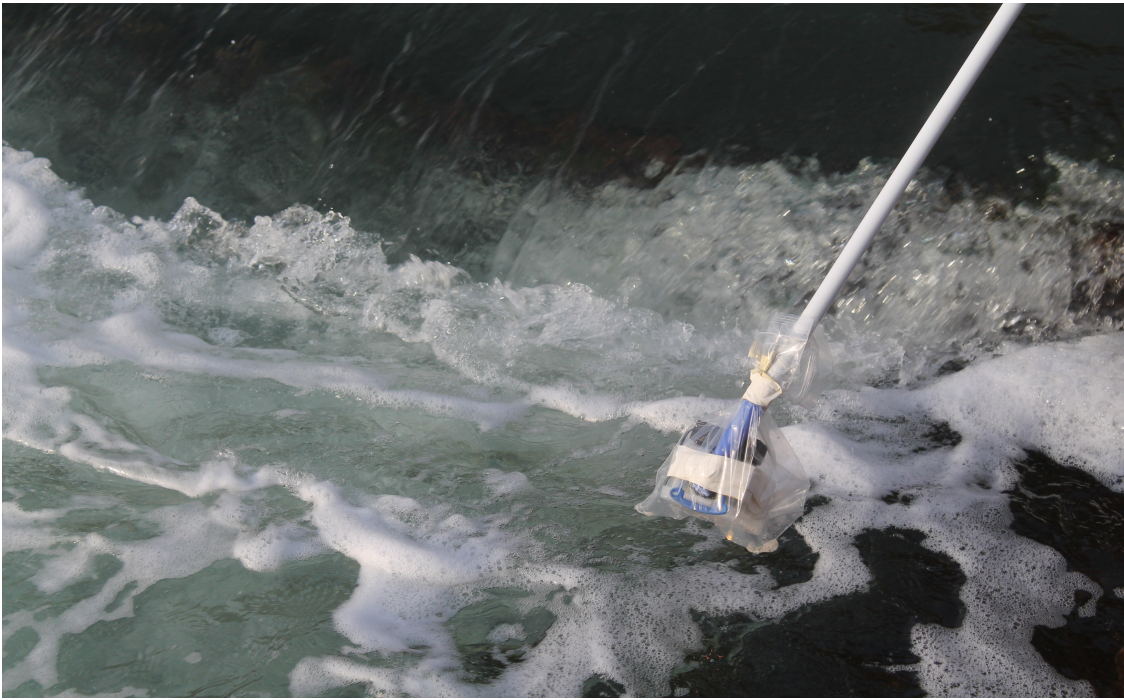
Image Three = #3 on map

Light = Orange
Temp = 56°F (13.33°C)

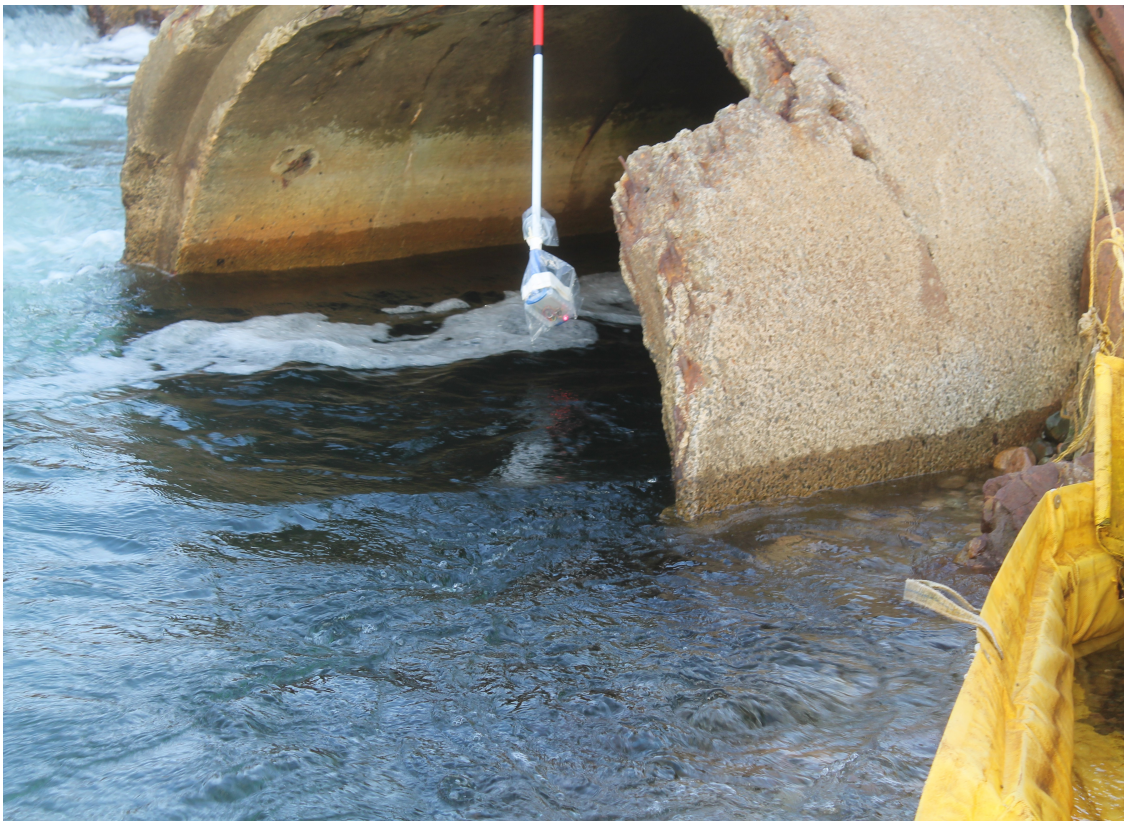
Image Four = #4 on map

Light = Red
Temp = 65°F (18.33°C)

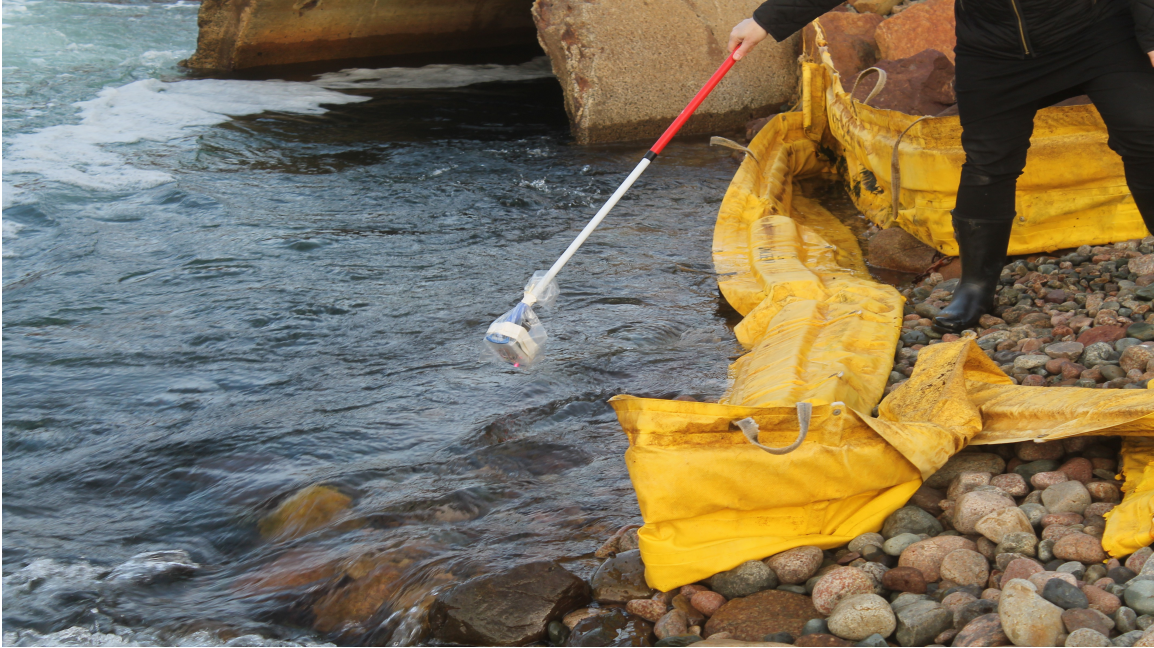
Image Five = #5 on map

Light = Red

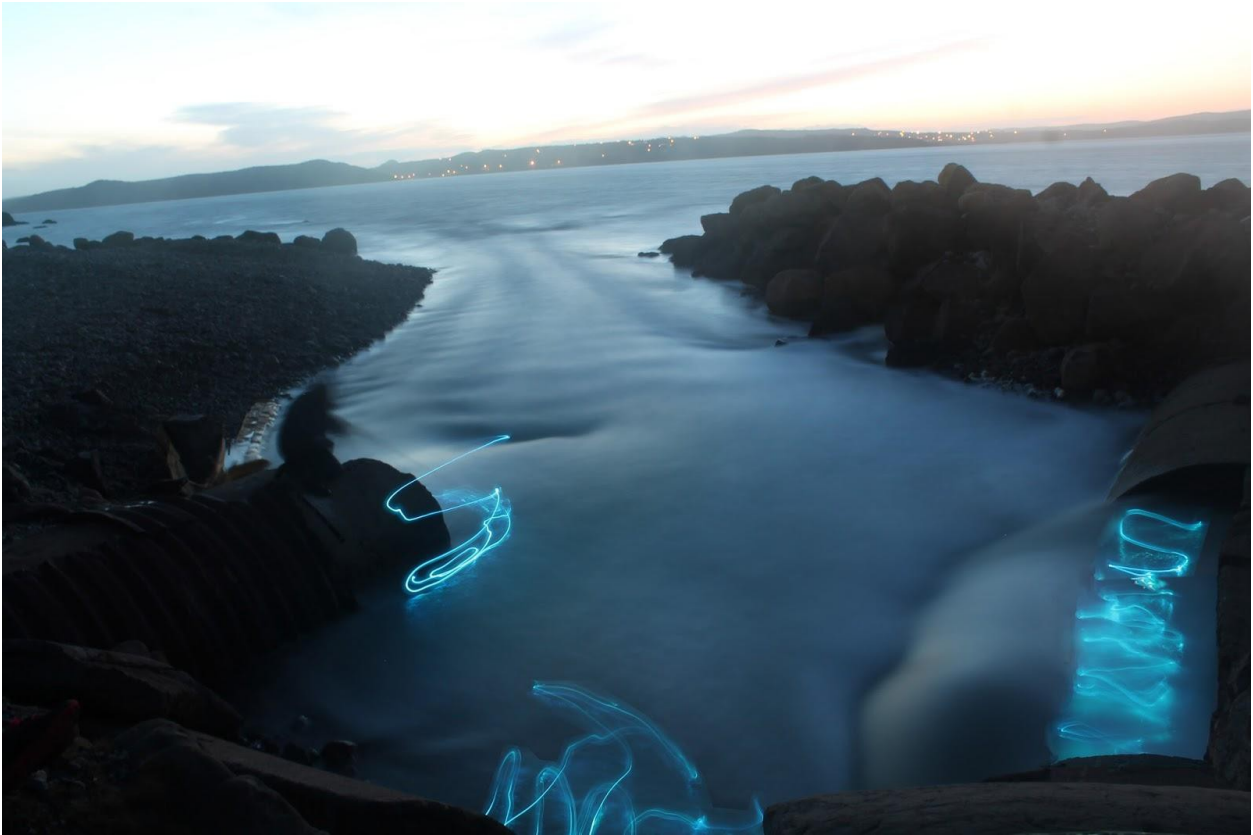
Here is a composite image with our flashlight:
